Manhole Inspection Summary

Manhole # S13MM1006MH

Insp Date: **12/6/06 9:10 AM**

Location Address: **3012 VIRGINIA AVE**

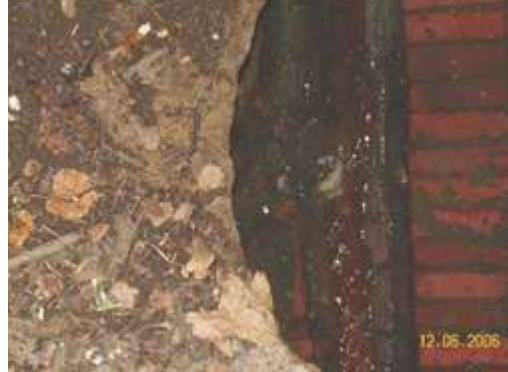
Top View

Comments **Due to the configuration of MH the top view does not show all of the pipes.**

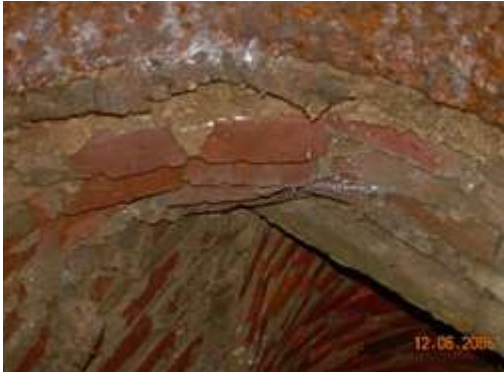
Defect

Condition: ☐ Sound ☐ Cracked ☐ Root Intrusion ☐ Loose Brick ☒ **Deteriorated**

Infiltration: ☐ None ☒ **Joint** ☐ Cracks ☒ **Mortar** ☐ Roots ☐ Wall

Steps Count: **3** Missing: **0** ☒ **Corroded**

Adjustment deterioration and infiltration.
Corroded steps.

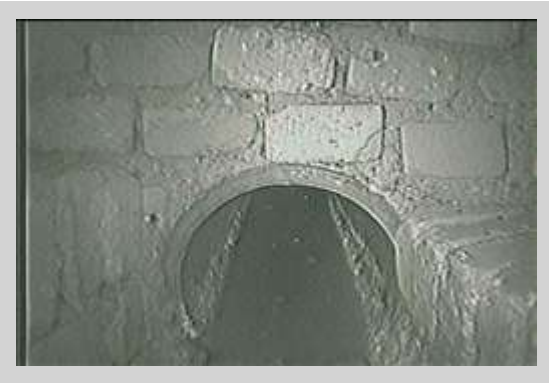
8 in. Circular Gravity Sewer Pipe Out @ 12 O'Clock

Deposits: ☐ None ☐ Mud ☐ Sludge ☐ Debris ☒ Grease

Silt Depth: **0** (in.) Deposits Extent: **Light**

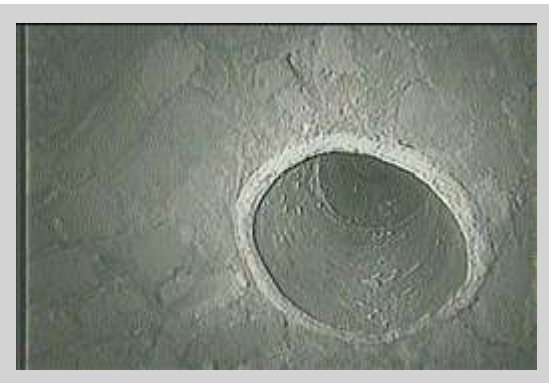
8 in. Circular Gravity Sewer Pipe In @ 6 O'Clock

Infiltration: **Evidence** Pipe Seal Cond: **Cracked**
